Memorandum

Date: *August 15, 2014*

Subject: *Oversight Summary Report
CPG Oversight of RM 10.9 Removal Action
Lower Passaic River Restoration Project*

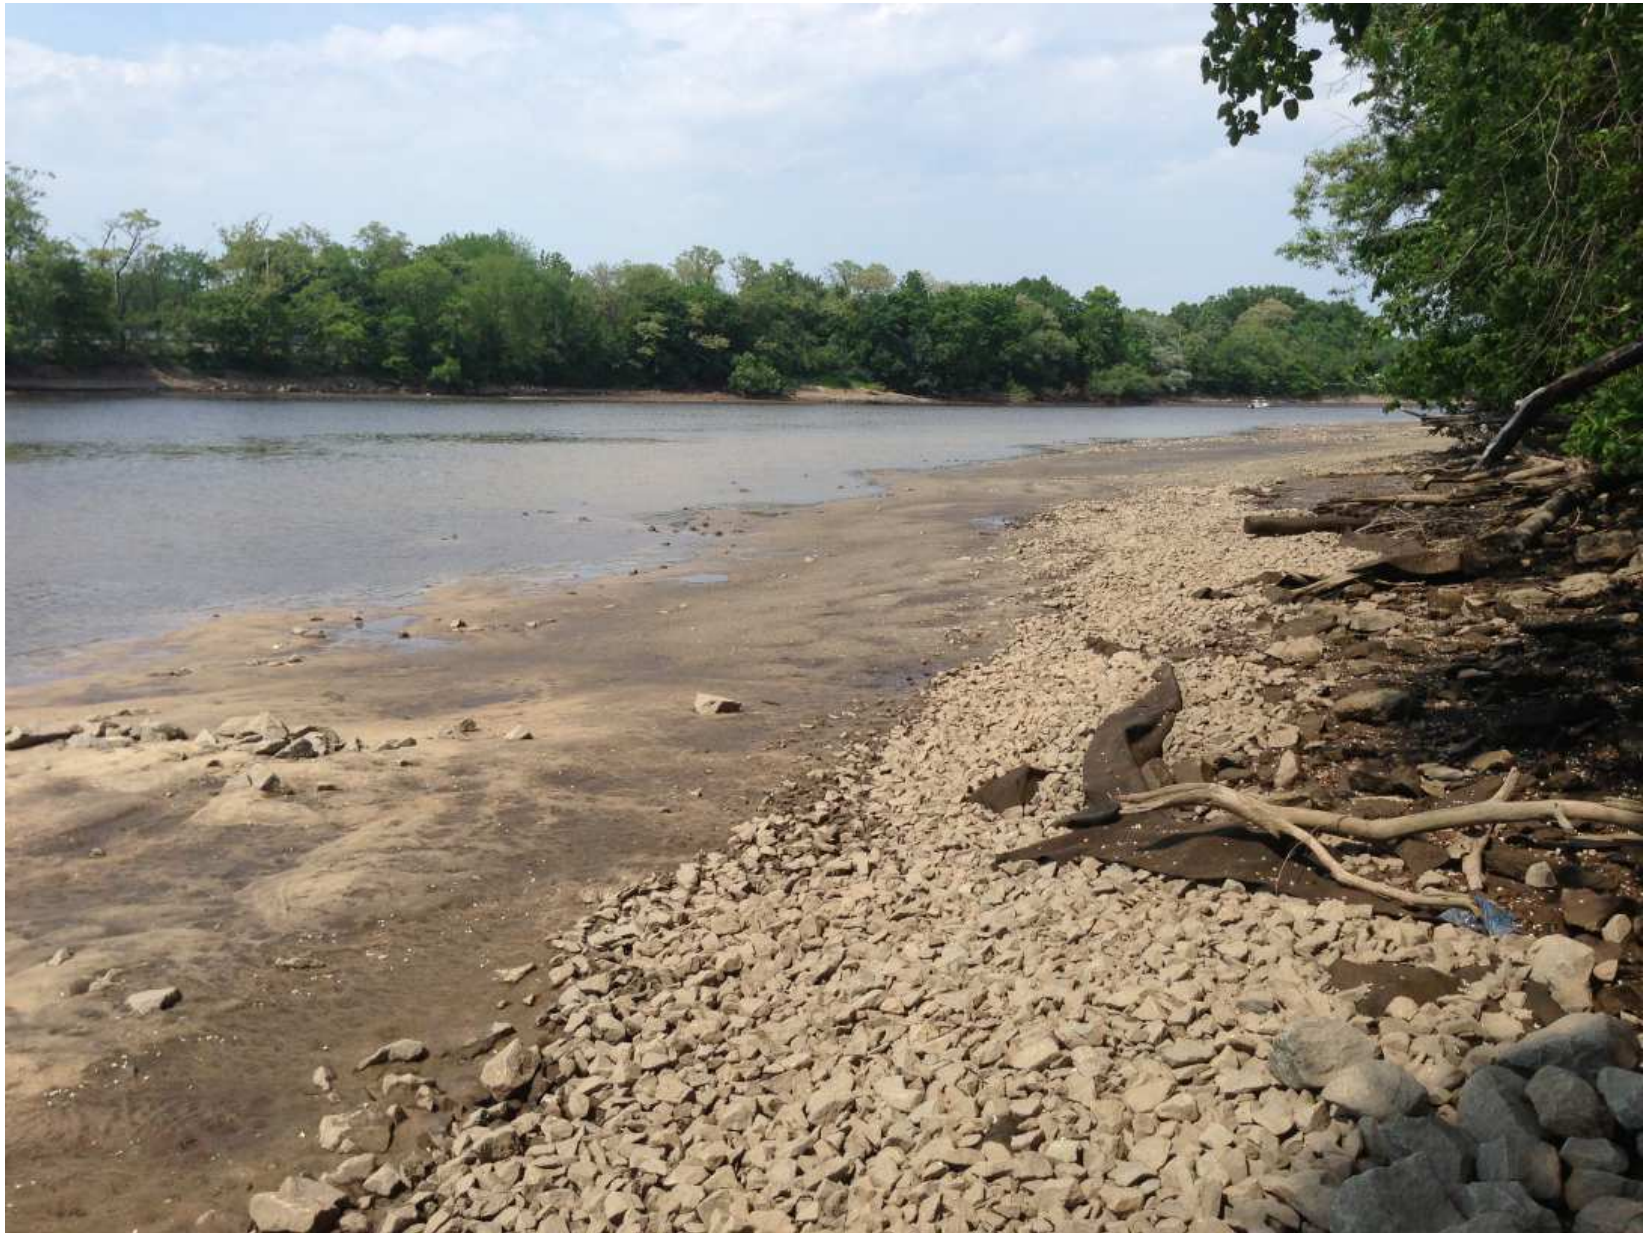
Near Southern Edge of Capping Area, Facing North

Abundance of extra armor stone (beyond the “dredge line”) shown.
